Manhole Inspection Summary

Manhole # S19CC1020MH

Insp Date: **6/28/07 11:05 AM**

Location Address: **DRUID PARK DR**

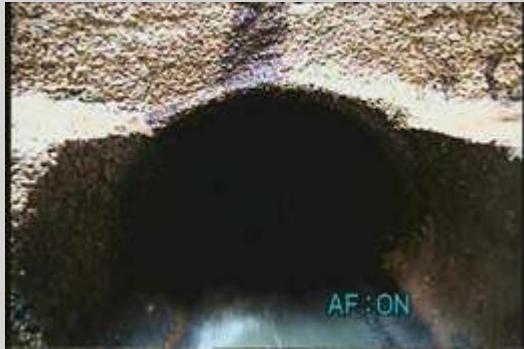
18 in. Circular Gravity Sewer Pipe Out @ 12 O'Clock

Pipe Material: **Unknown** ☒ Pipe Lined

Invert Depth: **11.40** (ft.) Flow Characteristics: **Fast**

Infiltration: **None** Pipe Seal Cond: **Unknown**

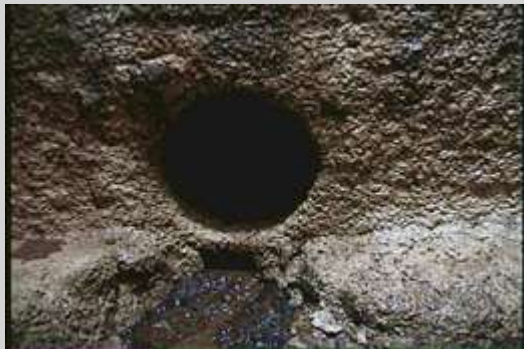
8 in. Circular Gravity Sewer Pipe In @ 3 O'Clock

Pipe Material: **Clay** ☐ Pipe Lined

Invert Depth: **10.00** (ft.) Flow Characteristics: **Slow**

Infiltration: **None** Pipe Seal Cond: **Unknown**

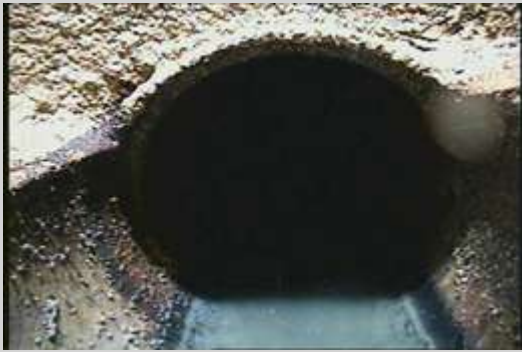
16 in. Circular Gravity Sewer

Pipe Material: **Unknown** ☒ Pipe Lined

Invert Depth: **11.23** (ft.) Flow Characteristics: **Fast**

Infiltration: **None** Pipe Seal Cond: **Unknown**

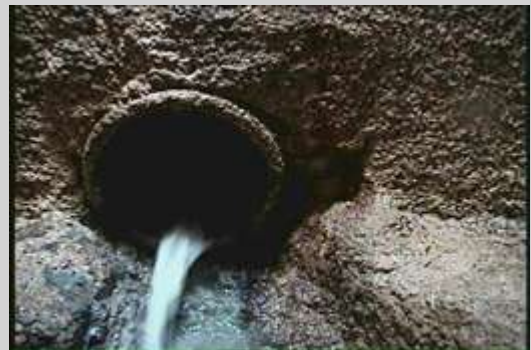
Drop In @ 9 O'Clock

Drop: **Outside** Rod and Bar
Angled: **Yes** Reading: **8.87** (ft.)
Inv Depth: **9.87** (ft.)

Drop Condition: **Open**
